Failure Analysis of a Sodium, Inconel 617 Heat Pipe

D. L. Jacobson and J. H. Wang

MECHANICAL AND AEROSPACE ENGINEERING
ARIZONA STATE UNIVERSITY
TEMPE, ARIZONA 85287

September 1985

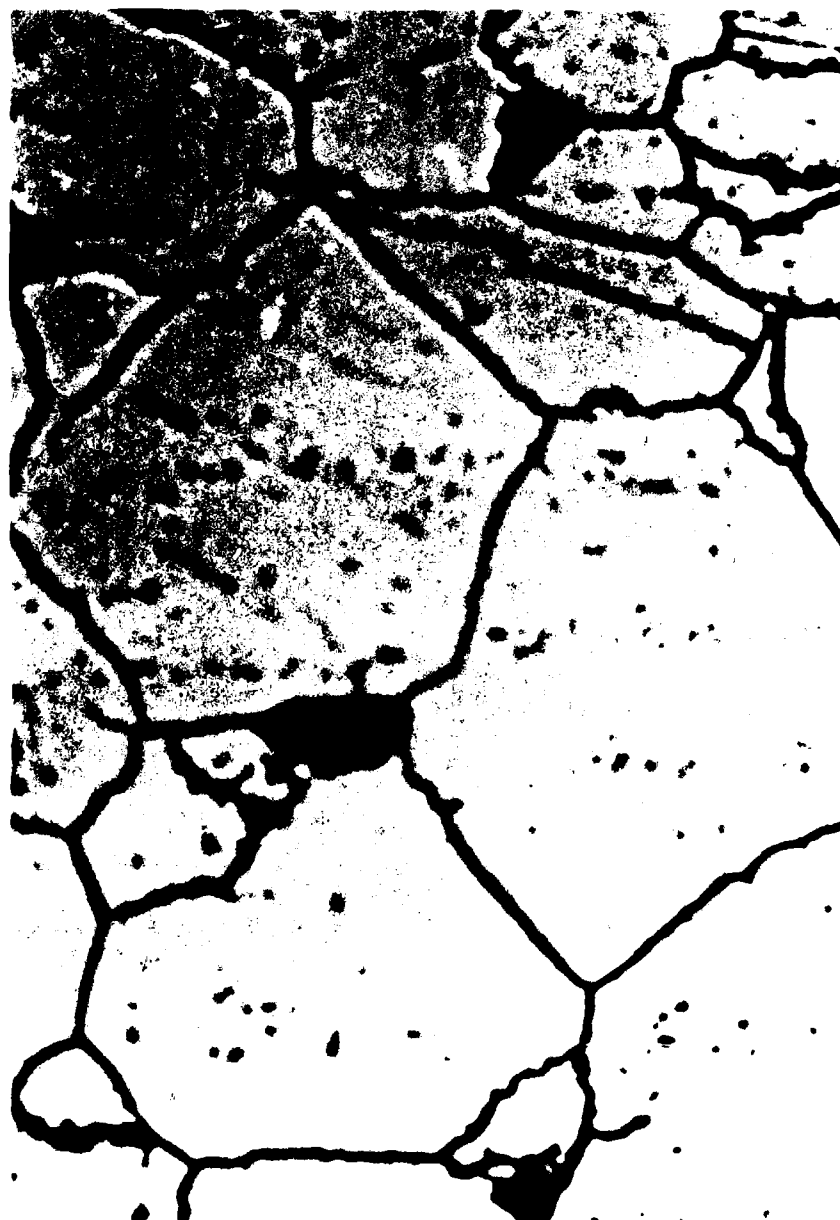
Table 1 gives the nominal composition of I617 which is a face-centered-cubic solid-solution strengthening alloy with a nickel-rich austenitic matrix phase. The microstructure in the cracked region shown in Fig. 11 showed relatively large precipitates at some grain intersections.

Microprobe analyses indicated that the composition was Cr₂₃C₆ which like sigma phase is brittle and will shorten the rupture life of the material. The phase is formed due to improper heat treatment whereby carbides migrate and accumulate at grain boundaries. Grain boundary cracks were found to coincide with these precipitates in many areas. Near the cracked areas microprobe analyses showed elevated levels of chromium and molybdenum. Small black particles in these areas were found to form continuous chains in the grain boundaries. The chains were estimated to be a combination of Cr₂₃C₆ and Mo₆C. Cr₂₃C₆ will form as a precipitate in the grain boundaries during heat treatment in the 1033K to 1253K range. The continuous chain results in fracture paths and low impact properties. Distributed or non continuous chains on the other hand are beneficial in hindering grain boundary cracking.⁵ Titanium carbide chains found in the material were the same throughout. Figure 12 shows precipitation from carbide accumulation.

Figure 11. Evaporator Region Precipitates (400X).

The long term exposure to the high evaporator temperatures caused precipitation of cellular CR₂₃C₆ and other carbides forming continuous carbide chains which result in embrittled grain boundaries. Operation in the sensitizing temperature range resulting in such precipitate chains must be avoided. Microprobe analyses revealed that phosphorous and copper were present in the corroded intergranular material but were not present in the matrix grains. Sulphur and iron were found in elevated amounts compared to the base metal. Analysis of a separated fracture surface also revealed elevated amounts of copper and sulphur with trace amounts of phosphorous and sodium. The phosphorous probably came from original I617 alloy preparation although some phosphorous plus copper may have arisen from brazing materials. Phosphorous and sulphur embrittle the structure and should be avoided.

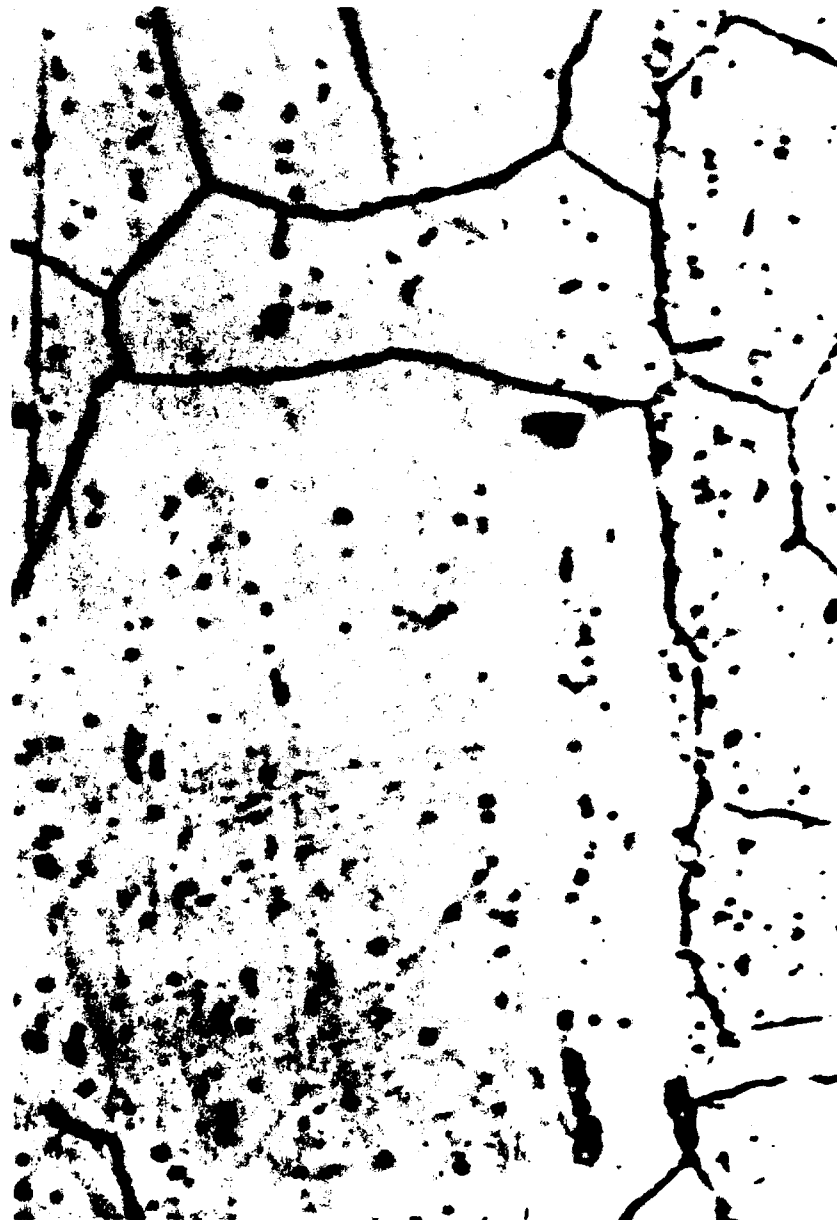
Figure 12. Formation of Precipitates by Carbide Accumulation.

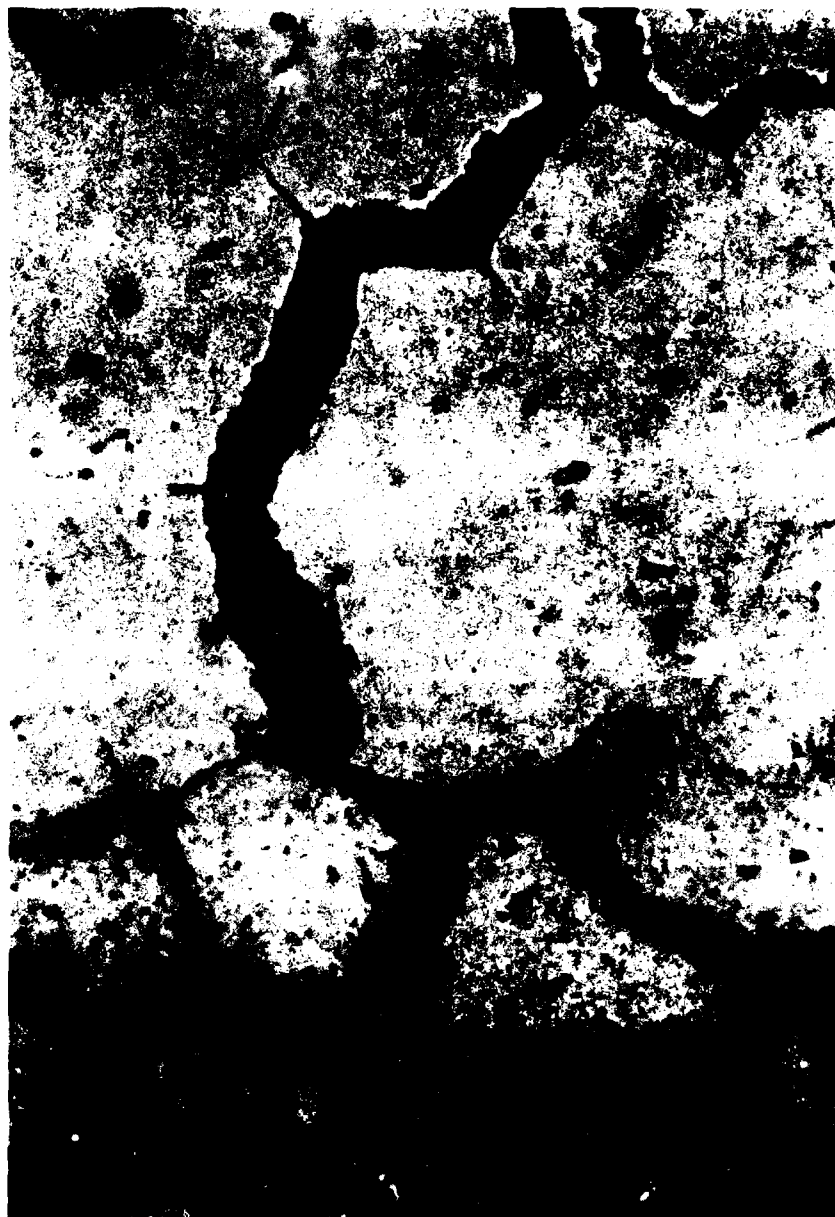
Metallography and SEM micrographs showed extensive intergranular attack. The sodium with its apparent high oxygen content produced the grain boundary penetration. Intergranular attack is shown in Figs. 10, 13 and 14. Part of the metallography and Scanning Emission Microscope (SEM) results were provided by the AFWAL Materials Laboratory.⁶ In some areas, entire grains were found to be separated from the matrix. The associated surfaces were consequently very rough from the corrosion. As seen in the above micrographs the cracks were generated in an intergranular fashion.

Figure 13. Grain Boundary Attack (500X)⁶.

Pure sodium, according to the literature should not present a corrosion problem in I617 in this heat pipe application. However, if the sodium is contaminated by as little as 10 to 20 ppm oxygen it is known to produce liquid metal embrittlement and the corrosion can be appreciable. Therefore, oxygen in the sodium heat pipe system should be reduced to the lowest possible level.
